# Jeffery Mathis Inspections

08:37 February 23, 2007

Page 1 of 14  
201 Placid Way.pt5

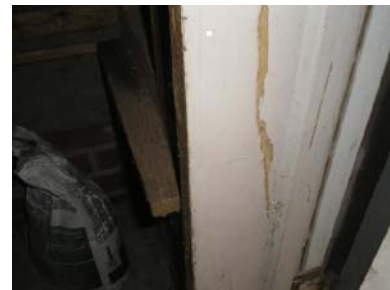
| 2. Marginal | Trim: Painted pine There is extensive insect damage to the storage room door jamb. Repair as needed. |

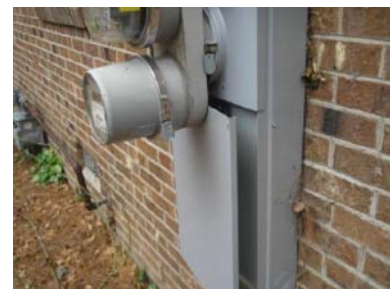
- 12. Not Inspected Main Breaker Size: 200 at exterior disconnect box
- 13. Acceptable Breakers: CU/AL
- 14. Is the panel bonded? No
- At meter Electric Panel \_\_\_\_\_
- 15. Acceptable Manufacturer: Cutler-Hammer
- 16. Max Capacity: 200 Amps
- 17. Not Inspected Main Breaker Size: 200 The panel at the meter is not accessible due to the meter set-up.

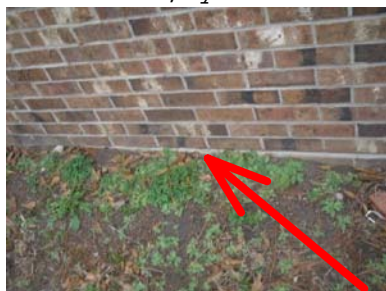
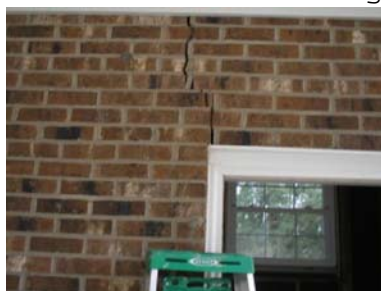
Differential Movement: Crack with displacement At the carport storage room door and along the right side of the storage room there is visible settling. It is not within the scope of a standard home inspection to evaluate the causes or implications of structural cracks. If they are a concern, you must consult a structural engineer.

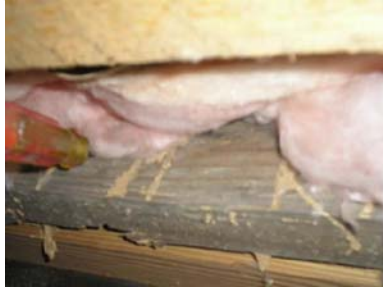
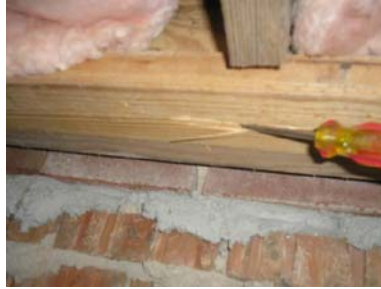
Beams: Laminated 2x10 There is visible evidence of a previous termite infestation in much of the bands and girders at the center to right side of the crawl space and as seen from in the storage room behind the water heater and return duct.

Some of the damage is substantial enough to warrant further consideration. The nature of termite activity is that tubes and surface damage may not undermine the structural integrity of the structure, but further invasive probing would be required. Excess deterioration was noted in the outer bands along the right side. (photos)

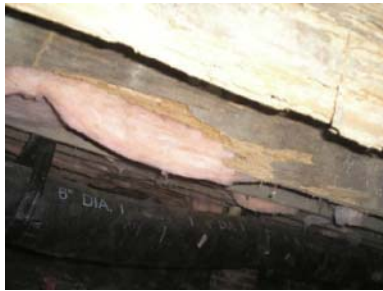
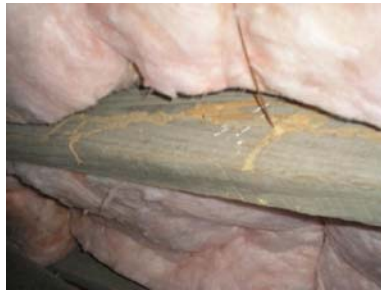
**Bearing Walls: Frame** There is evidence of some termite activity in the studs in the storage room. The visible activity does not appear to be structurally significant.

**Joists/Trusses: 2x10** At the right side of the house from the front door to the right corner, there is evidence of termite activity and some significant deterioration. Further evaluation and repair by a qualified structural repair contractor is recommended.

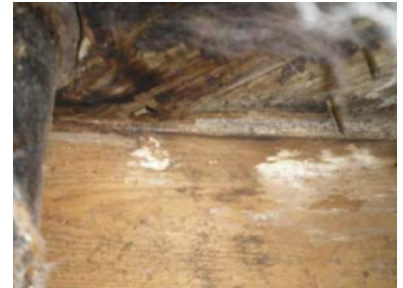
**Subfloor: 3/4 pine boards** Under the rear bathroom toilet, there is some deteriorated flooring and damage in the adjacent joists due to an on-going or recently corrected leak at the toilet. The damage is visible, but structural implications may be minimal.

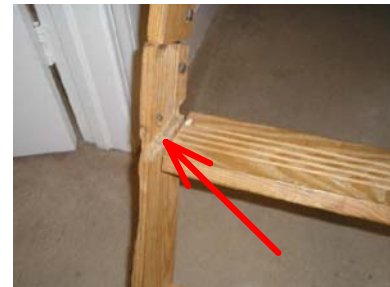
- 1. Method of Inspection: In the attic areas
- 2. Defective      **Unable to Inspect:** 0% Please be aware of the attic stairs. 2 treads are pulled out of the stringer and needs repair prior to extensive use.

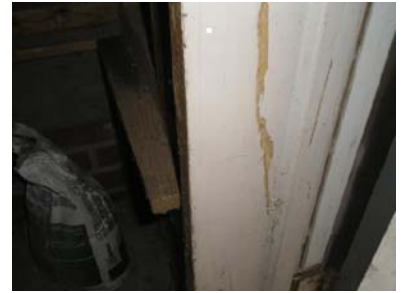
1. **Trim: Painted pine** There is extensive insect damage to the storage room door jamb. Repair as needed.

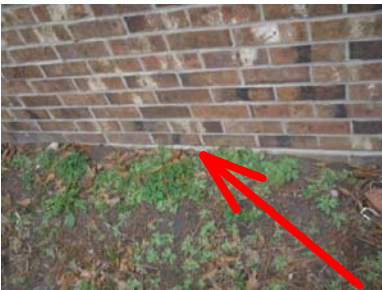
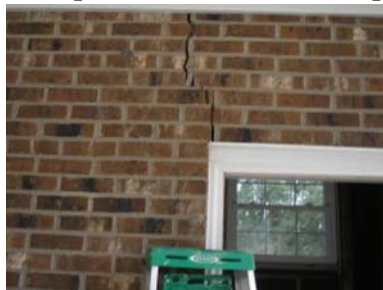
7. **Differential Movement: Crack with displacement** At the carport storage room door and along the right side of the storage room there is visible settling. It is not within the scope of a standard home inspection to evaluate the causes or implications of structural cracks. If they are a concern, you must consult a structural engineer.

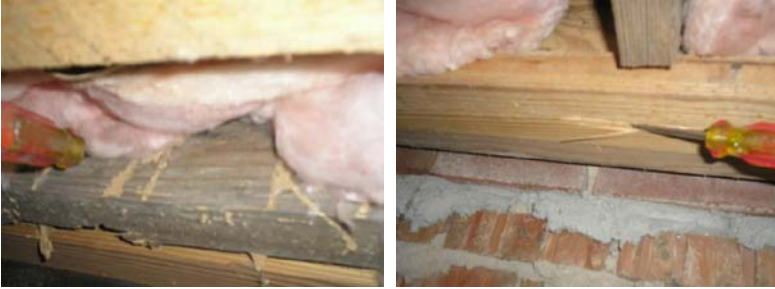
8. **Beams: Laminated 2x10** There is visible evidence of a previous termite infestation in much of the bands and girders at the center to right side of the crawl space and as seen from in the storage room behind the water heater and return duct. Some of the damage is substantial enough to warrant further consideration. The nature of termite activity is that tubes and surface damage may not undermine the structural integrity of the structure, but further invasive probing would be required.

Excess deterioration was noted in the outer bands along the right side. (photos)

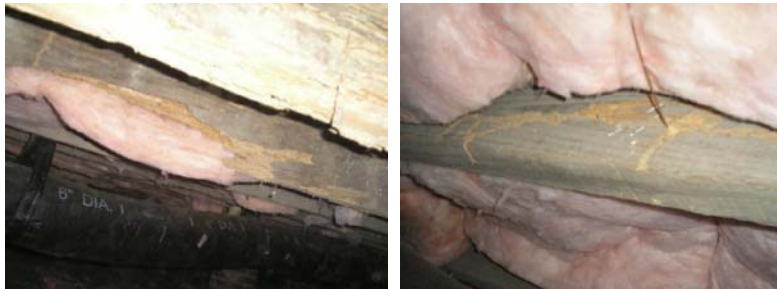
9. **Bearing Walls:** Frame There is evidence of some termite activity in the studs in the storage room. The visible activity does not appear to be structurally significant.
10. **Joists/Trusses:** 2x10 At the right side of the house from the front door to the right corner, there is evidence of termite activity and some significant deterioration. Further evaluation and repair by a qualified structural repair contractor is recommended.

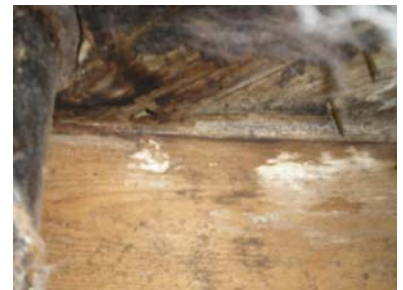
11. **Subfloor:** 3/4 pine boards Under the rear bathroom toilet, there is some deteriorated flooring and damage in the adjacent joists due to an on-going or recently corrected leak at the toilet. The damage is visible, but structural implications may be minimal.

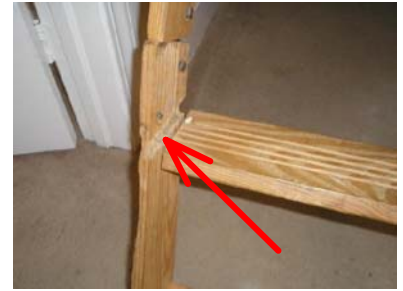
2. All Attic Unable to Inspect: 0% Please be aware of the attic stairs. 2 treads are pulled out of the stringer and needs repair prior to extensive use.
